### **Monitoring Streambanks and Riparian Vegetation**

Multiple Indicator Monitoring

Ervin Cowley and Tim Burton

June 2004

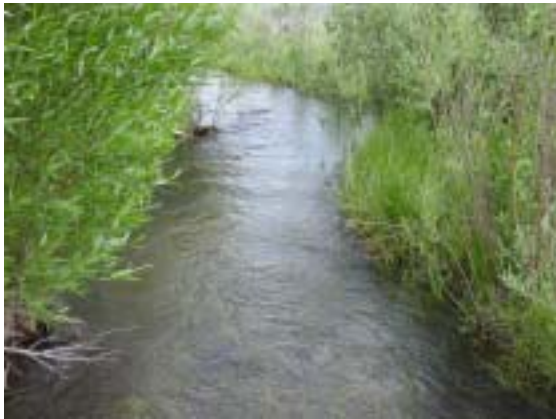
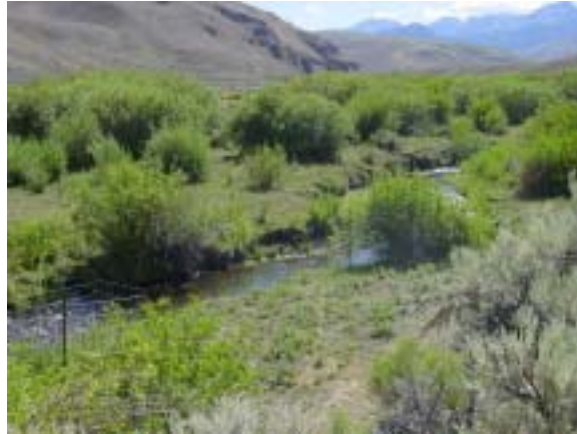
**II. “C” channel type, mixed shrub - herbaceous vegetation dominant, potential vegetation: mixed herbaceous and shrubs, or shrubs.**

- **TRIGGER: Within-season trigger to move livestock, to maintain or increase vigor on key hydric stabilizers:**
  - Stubble height on key riparian species or species groups on the greenline

- Use compliance (livestock numbers and time in pasture).
  - Bank disturbance or alteration
  - Change in preference to woody species sprouts and young

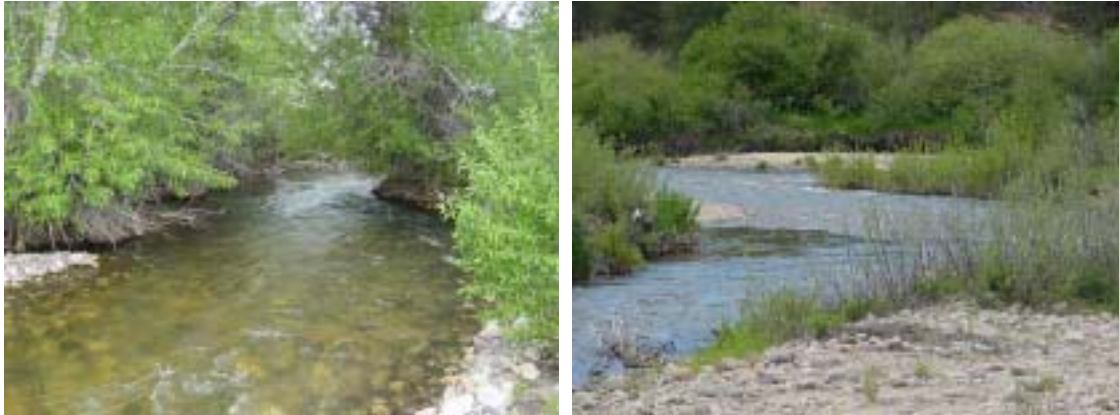
- **III. “C” channel type, woody dominant, potential vegetation: shrubs and trees.**

- **TRIGGER: Within-season trigger to move livestock, to maintain or increase vigor on key hydric stabilizers:**
  - Use compliance (livestock numbers and time in pasture).
  - Bank disturbance or alteration
  - Change in preference to woody species sprouts and young
- **ENDPOINT: End-of-season indicator of proper use to maintain or ensure increased composition key hydric stabilizers:**
  - Bank disturbance or alteration
  - Incidence of use on woody sprouts and young
- **RIPARIAN OBJECTIVE: Long-term indicator of riparian condition to assess attainment of the Riparian Management Objectives**
  - Streambank stability
  - Woody species regeneration – 15-20% sprouts and young, 60-70% mature, and 15-20% dead
  -

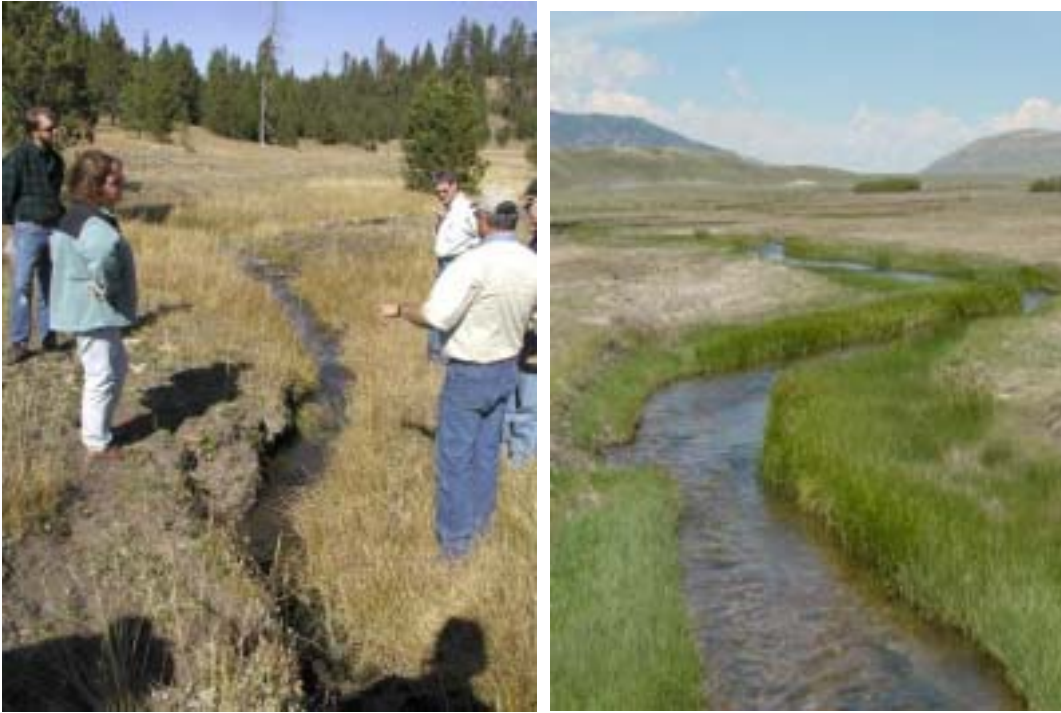
**IV. “E” channel type, herbaceous vegetation dominant, potential vegetation: herbaceous or mixed herbaceous and shrubs.**

- **TRIGGER: Within-season trigger to move livestock, to maintain or increase vigor on key hydric stabilizers:**
  - Stubble height on key riparian species, or species groups on the greenline.
  - Use compliance (livestock numbers and time in pasture).
  - Bank disturbance or alteration
- **ENDPOINT: End-of-season indicator of proper use to maintain or ensure increased composition key hydric stabilizers:**
  - Stubble height on key riparian species, or species groups on the greenline.
  - Bank disturbance or alteration.
- **RIPARIAN OBJECTIVE: Long-term indicator of riparian condition to assess attainment of the Riparian Management Objectives**
  - Streambank stability.
  - Greenline composition maintained or trend toward hydric stabilizers

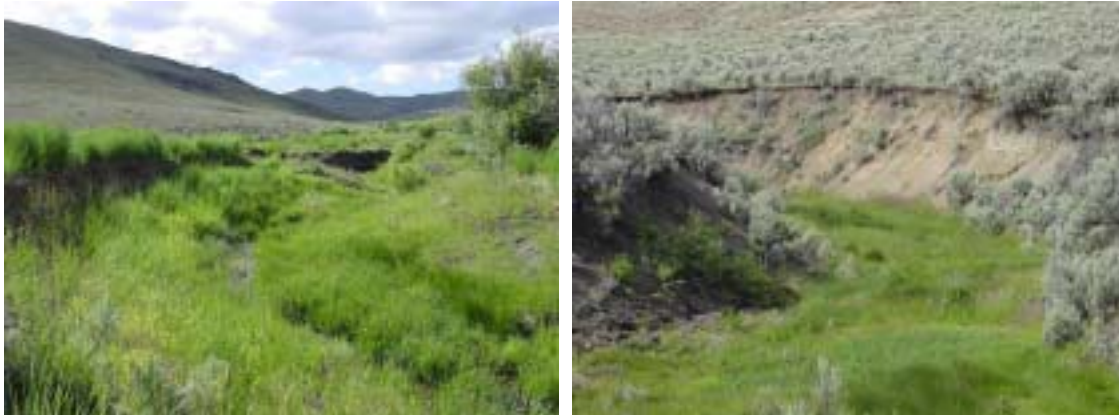
**V. “F” channel type (entrenched floodplain), herbaceous vegetation dominant, potential vegetation: herbaceous or mixed herbaceous and shrubs.**

- **TRIGGER: Within-season trigger to move livestock, to maintain or increase vigor on key hydric stabilizers:**
  - Stubble height on key riparian species, or species groups on the greenline.
  - Use compliance (livestock numbers and time in pasture).
  - Bank disturbance or alteration
- **ENDPOINT: End-of-season indicator of proper use to maintain or ensure increased composition key hydric stabilizers:**
  - Stubble height on key riparian species, or species groups on the greenline.
  - Bank disturbance or alteration.
- **RIPARIAN OBJECTIVE: Long-term indicator of riparian condition to assess attainment of the Riparian Management Objectives**
  - Streambank stability.
  - Greenline composition maintained or trend toward hydric stabilizers

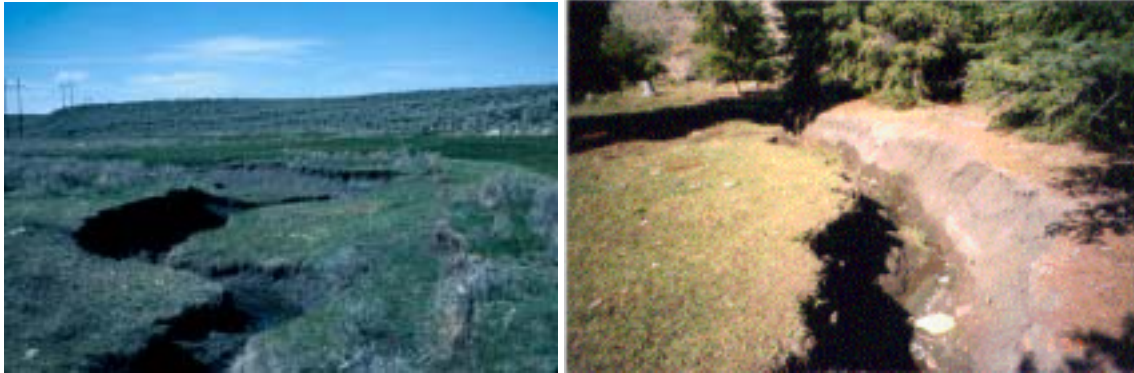
**VI. “G” channel type (entrenched – no floodplain), herbaceous vegetation or bare banks dominant. Potential vegetation: herbaceous.**

- **TRIGGER: Within-season trigger to move livestock, to maintain or increase vigor on key hydric stabilizers:**
  - Use compliance (livestock numbers and time in pasture).
  - Bank disturbance or alteration
- **ENDPOINT: End-of-season indicator of proper use to maintain or ensure increased composition key hydric stabilizers:**
  - Bank disturbance or alteration.
- **RIPARIAN OBJECTIVE: Long-term indicator of riparian condition to assess attainment of the Riparian Management Objectives**
  - Streambank stability.
  - Greenline composition maintained or trend toward hydric stabilizers

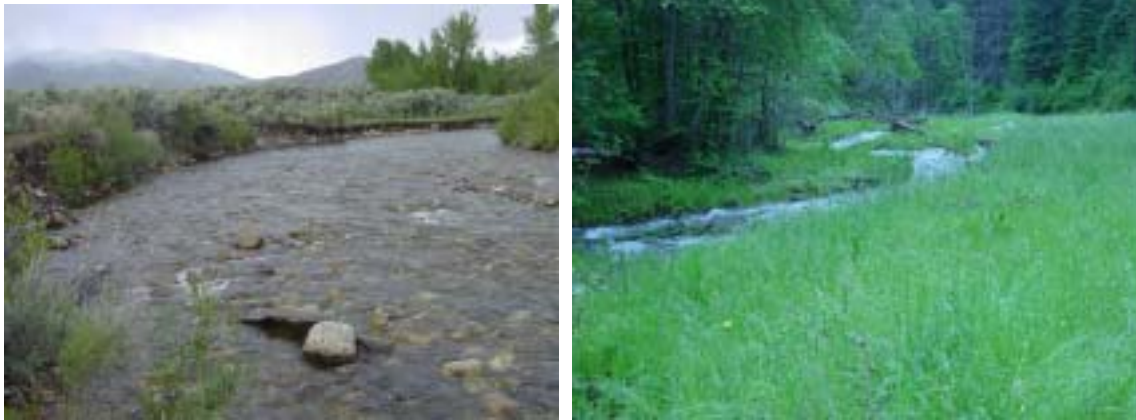
**VI. “B” channel type, mixed shrub - herbaceous vegetation dominant, potential vegetation: mixed herbaceous and shrubs, or shrubs.**

- **TRIGGER: Within-season trigger to move livestock, to maintain or increase vigor on key hydric stabilizers:**
  - Stubble height on key riparian species, or species groups on the greenline

- Use compliance (livestock numbers and time in pasture).
  - Bank disturbance or alteration
  - Change in preference to woody species sprouts and young

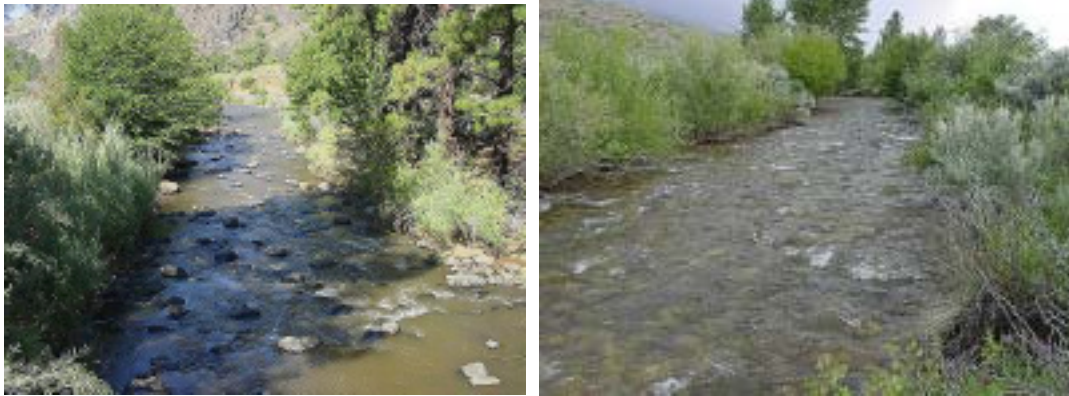
- **VII. “B” channel type, woody dominant, potential vegetation: Shrubs and trees.**

- **TRIGGER: Within-season trigger to move livestock, to maintain or increase vigor on key hydric stabilizers:**
  - Use compliance (livestock numbers and time in pasture).
  - Bank disturbance or alteration
- **ENDPOINT: End-of-season indicator of proper use to maintain or ensure increased composition key hydric stabilizers:**
  - Bank disturbance or alteration
  - Incidence of use on woody sprouts and young
- **RIPARIAN OBJECTIVE: Long-term indicator of riparian condition to assess attainment of the Riparian Management Objectives**
  - Streambank stability
  - Woody species regeneration – 15-20% sprouts and young, 60-70% mature, and 15-20% dead

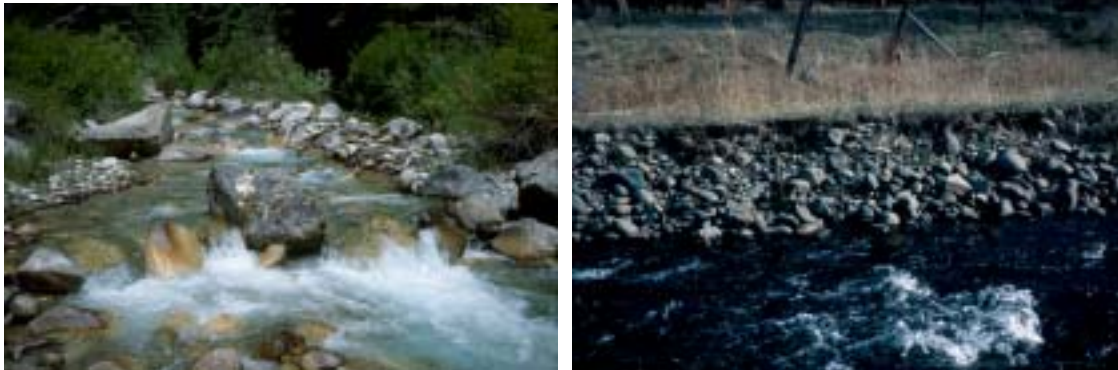
**VIII. “A” channel. Mixed shrubs and herbaceous, or shrubs dominant. Potential vegetation: mixed shrubs and herbaceous, or shrubs. Substrate large.**

- **TRIGGER: Within-season trigger to move livestock, to maintain or increase vigor on key hydric stabilizers:**
  - Use compliance (livestock numbers and time in pasture).
  - Bank disturbance or alteration
  - Change in preference to woody species sprouts and young
- **ENDPOINT: End-of-season indicator of proper use to maintain or ensure increased composition key hydric stabilizers:**
  - Bank disturbance or alteration
  - Incidence of use on woody sprouts and young
- **RIPARIAN OBJECTIVE: Long-term indicator of riparian condition to assess attainment of the Riparian Management Objectives**
  - Streambank stability
  - 
  - Woody species regeneration – 15-20% sprouts and young, 60-70% mature, and 15-20% dead

Herbaceous vegetation does not normally contribute significantly to the stability of A channels. The rare exception would likely be associated with A5 and A6 channel types. A5's are steep channels incised in sandy materials and that occur on highly weathered granites or sedimentary rocks. Such channels often experience natural bank erosion through fluvial and earthflow processes. A6's are steep, entrenched channels in weathered shales and lacustrine soils that are very cohesive. These channels tend to be naturally unstable, but herbaceous vegetation may contribute some stability. Overgrazing may exacerbate an already unstable situation in steep channels with fine substrates.
